## CONTENT

### Fatigue Failures in Industry and Their Repairs – Case Studies

## Failure analysis of the rolls with grooves

## Failure of two overhead crane shafts

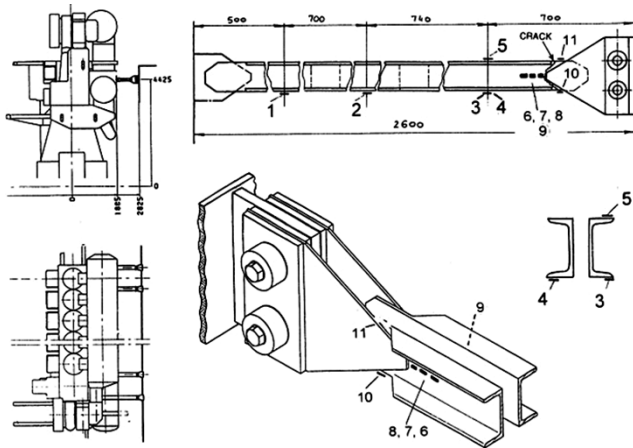
**Fig. 2.** Lateral engine support with observed failures and setup of the measurements for stress determination

of the joint. In order to obtain maximum stress, three strain gages were applied (15-17), Fig. 2. As all four supports were not manufactured geometrically identically, on the other side of support 3, strain gage 18 was applied as well as gages 21, 22, 23 on supports 1, 2, 4, respectively. A significant difference of the measured axial forces between the supports was detected. One of the beams was loaded with approx. 50% lower load. However, maximum axial force  $F = 20$  kN (calculated from the nominal stresses) was within the range of design load values. Measurements gave no significant bending moments. The results of nominal stresses ( $\sigma = 10, 15$  MPa) could not be the reason for fatigue cracks, in spite of observed differences from one support to others. Stresses at the crack initiation points were measured to evaluate the quality of design. Three strain gages (15, 16 and 17) were used for extrapolation of maximal stresses. Maximum stresses at the welds toe are extrapolated. Their amplitudes vary depending on the weld design, but the measured values of 70 or even 80 MPa could easily cause the initiation and propagation of fatigue cracks.

weeks of service. This service life is too short, compared with expected 20 years. This prediction had good agreement with the time to failure observed on the former ships. Failures are mainly caused by the inadequate joint design, the support and ship (hull) structure from one side, and insufficient weld quality. Namely, stress concentration factor in the critical area  $s_{loc}/s_{nom} \sim 5$  was quite unacceptable. It should be not more than 2 – 2.5, and a complete reconstruction of this important detail was necessary.

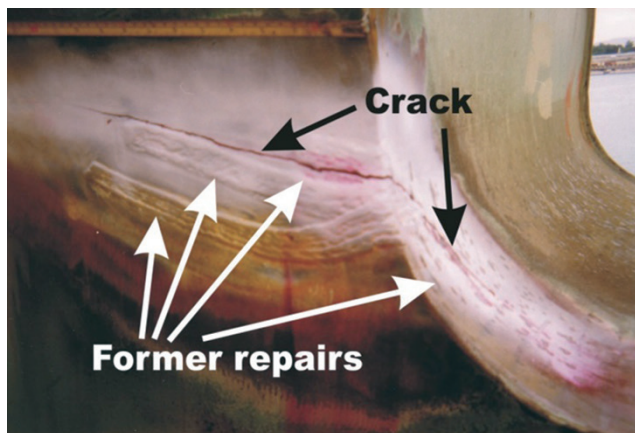
Cracks occurred at transition areas from vertical to horizontal supports on both legs, growing from the corners and bringing into danger the whole construction, Fig. 4. The first cracks were detected soon after the crane was

placed in the shipyard, so the allowed carrying capacity was reduced from 250 kN to 50 kN, figure 4, but the cracks continued to grow. In order to find the source of crack initiation and growth, the complete documentation and calculations were checked. It was found that calculations were performed by using simple beam elements, without taking into account stress concentration, and influences of inertial forces and wind were underestimated. Those facts led us to perform complete static and fatigue analysis, to measure real stresses during typical manoeuvres and to redesign the critical places of the crane.

Fig. 5. Detected cracks

The sharp transition from vertical to horizontal plates at the crane leg caused the initiation and growth of fatigue cracks that endangered the whole construction. By replacing the plates with cracks and applying the stiffeners at the places of the crack initiation, the sources of fatigue damages were removed and the maximum stresses at the redesigned construction were lowered to approximately one half of the previous values. Later examinations of the crane construction confirmed the success of this repair – two years after repair no new cracks were detected.

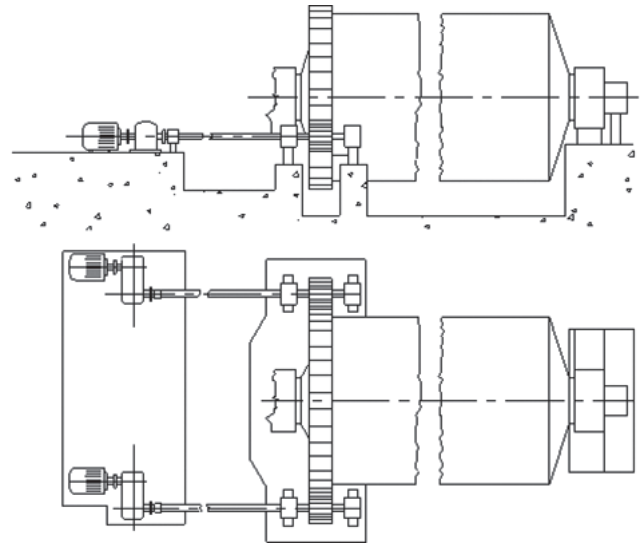
After 20 years in service, the great gear wheel of cement mill, Fig. 8, failed due to fatigue. When the whole mill plant was stopped and inspected, additional seventeen fatigue cracks were found at the tooth fillets. The gear wheel was fabricated of cast steel and mounted in two ring parts at the front side of the cement mill, Fig. 8.

At several positions, very close to the surface, a lot of casting errors (pores, slag inclusions, etc.) were found, Fig. 8. Joint efforts of alternating stresses, casting errors (sized several millimeters to several centimeters) and most likely existence of residual tensile stresses caused fatigue cracks initiation and propagation at the critical positions. The cross section of the gear rim, where complete fatigue failure occurred (fatigue crack No. 2), was additionally weakened by decreasing the rim thickness due to connecting bolts. The position of the cracks is shown in Fig. 7. The surface crack length varied from 20 mm to 600 mm (total failure). The position and size (surface length) of each discovered crack were estimated by means of non-destructive testing (magneto-flux method). In order to determine the complete data on crack shape and size (depth), and to perform repair welding, voluminous work (cracks removal by arc-air grooving) was undertaken.

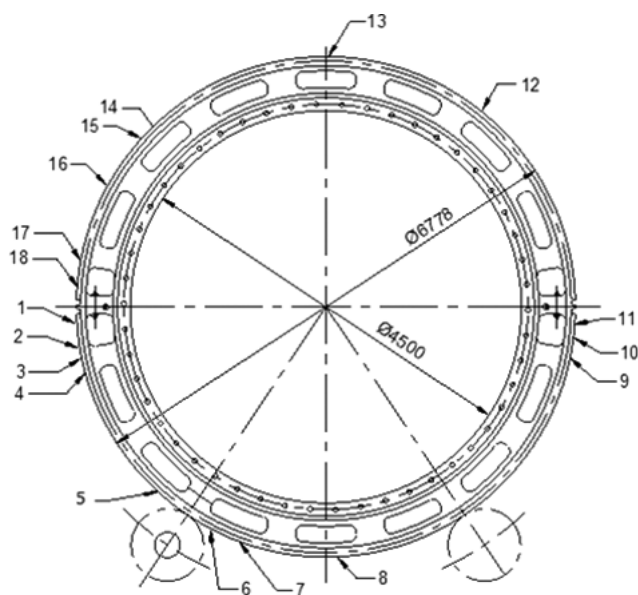
Fatigue crack number	Crack position (teeth number)	Crack surface length (mm)
1	2-3	200
2	3-4	600, failure
3	16-17	290
4	19-20	330
5	24-25	20
6	26-27	315
7	32-33	50
8	63-64	320
9	112-113	250
10	113-114	180
11	114-115	200
12	158-159	100
13	168-169	400
14	209-210	160
15	210-211	60
16	216-217	120
17	229-230	200
18	230-231	90

Fig. 9. Detected cracks on the cement mill

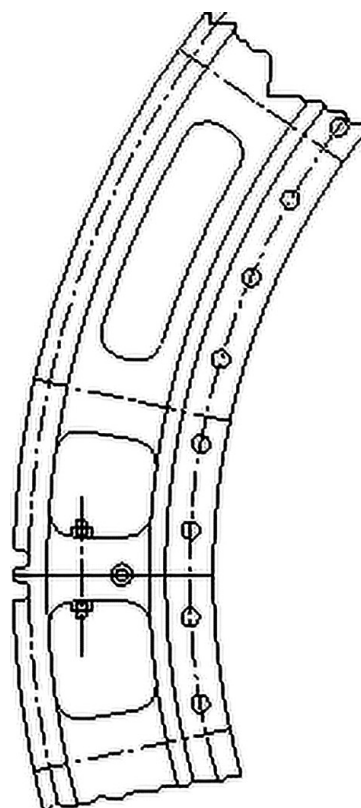
Fig. 10. Additionally weakened gear by decreasing the rim thickness due to connecting bolts (position 2 from Fig. 7)

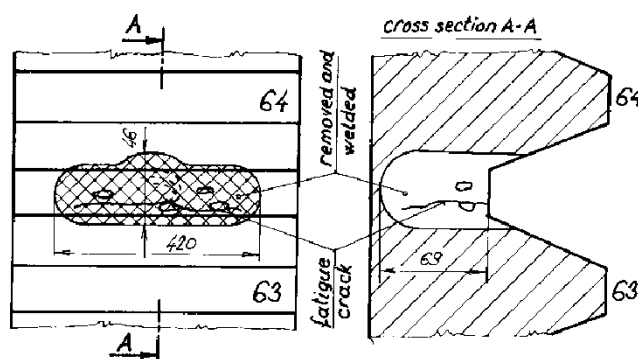
Fig. 11. Typical fatigue crack on the cement mill

All described activities took two months and cost approx. \$50 000 instead of \$300 000 for a new gear ring and four months for its delivery and assembly. Three years after repair and frequent controls during the service, no further cracks were reported.

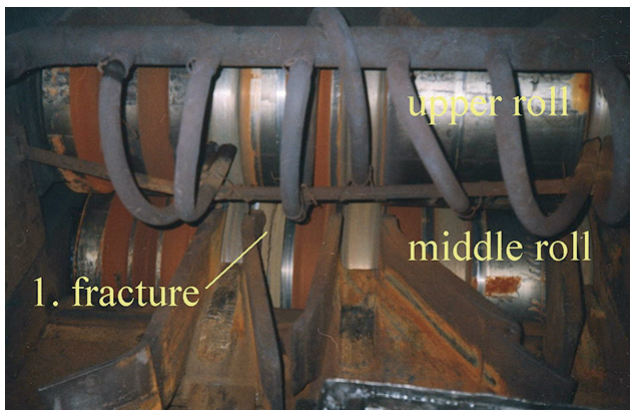
The first roll (middle roll) broke after 13 hours of operation. Figure 3 shows the position of the 1<sup>st</sup> fracture.

Fig. 3. Position of 1<sup>st</sup> fracture (back side of the stand)

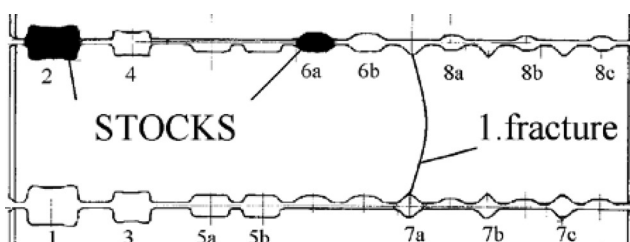
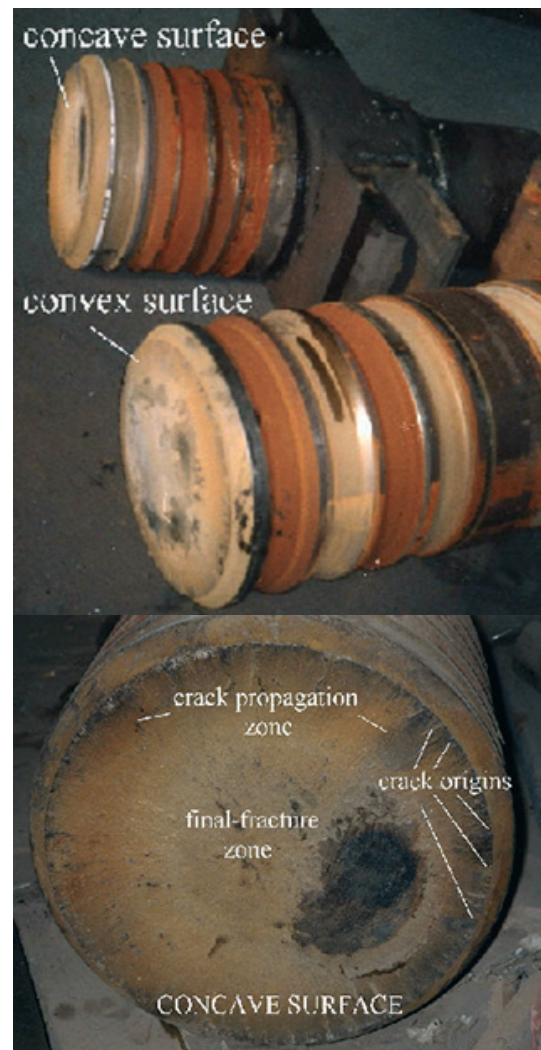
Fig. 4. Fracture surfaces of the 1<sup>st</sup> broken roll and the position of the stocks at the time of the fracture

Visual examination of the fracture surfaces of the 1<sup>st</sup>, 2<sup>nd</sup> and 4<sup>th</sup> broken roll revealed three fracture regions as shown in Fig. 4, Fig. 5 and Fig. 7: crack origin zone on the periphery, crack propagation zone and final fracture zone. The fracture surfaces of the 2<sup>nd</sup> and 4<sup>th</sup> broken roll were flat while the fracture surface of the 1<sup>st</sup> broken roll was curved. No surface irregularities and no fire cracks were present in the fracture surfaces and around the fracture surfaces on the surface of the grooves. The appearance of the fracture surfaces suggested low-cycle fatigue resulting from rotational-bending loading with a high stress concentration.

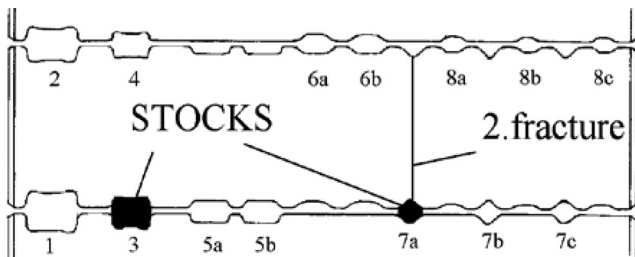
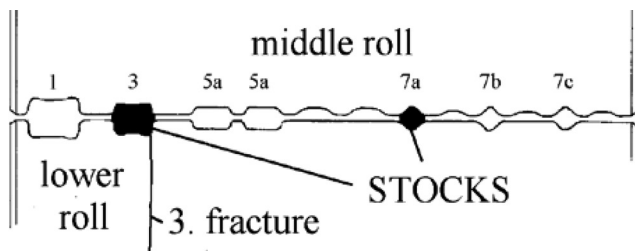
dressing. Figure 5 shows the fracture surfaces of the 2<sup>nd</sup> broken roll with the position of the stocks at the time of the fracture.

Fig. 5. Fracture surfaces of the 2<sup>nd</sup> broken roll and the position of the stocks at the time of the fracture

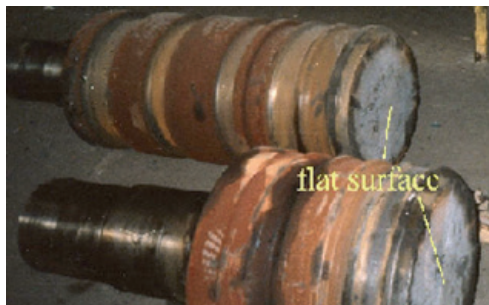
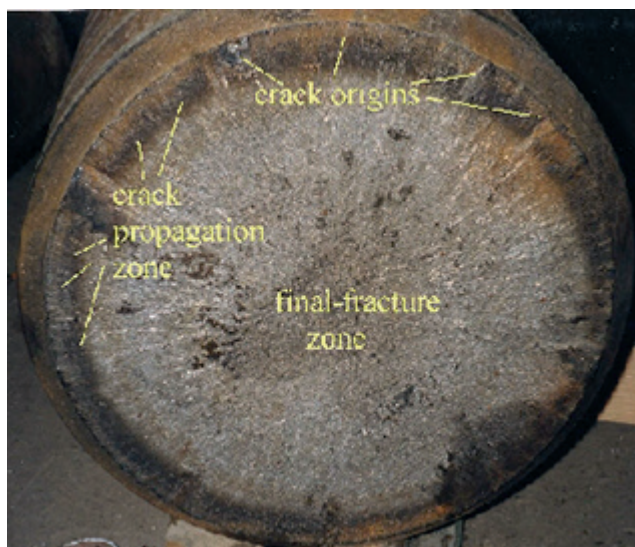
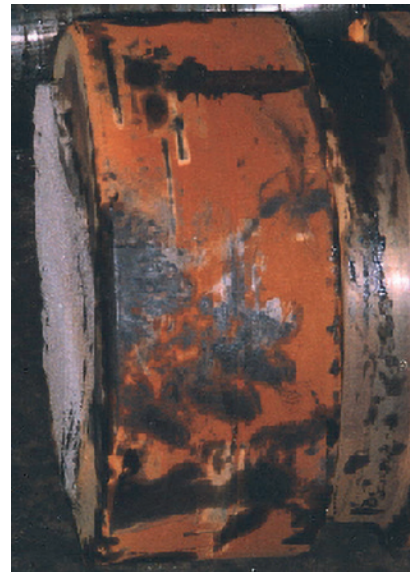
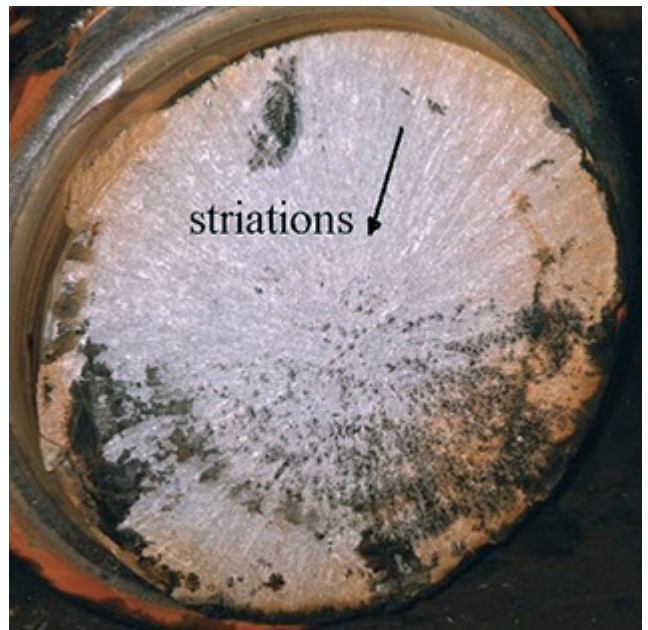
The third roll (lower roll) was dressed two times, after 4000 rolling tons and then after 8000 rolling tons. This roll broke after a short time of operation after the second dressing. Figure 6 shows the third broken roll and the fracture surface with the position of the stocks at the time of fracture.

Fig. 6. Fracture surfaces of the 3<sup>rd</sup> broken roll and the position of the stocks at the time of the fracture

Visual examination of the fracture surface of the 3<sup>rd</sup> broken roll revealed only one fracture region with rough striations from the surface to the centre of the roll. The appearance of the fracture surface of this roll suggested that the fracture occurred rapidly due to overload by dynamic impact.

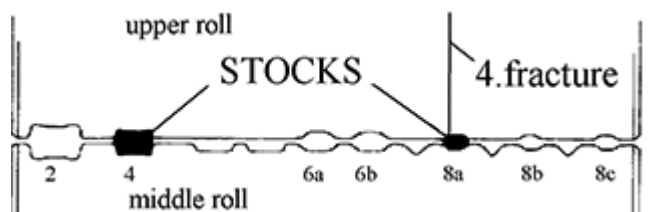
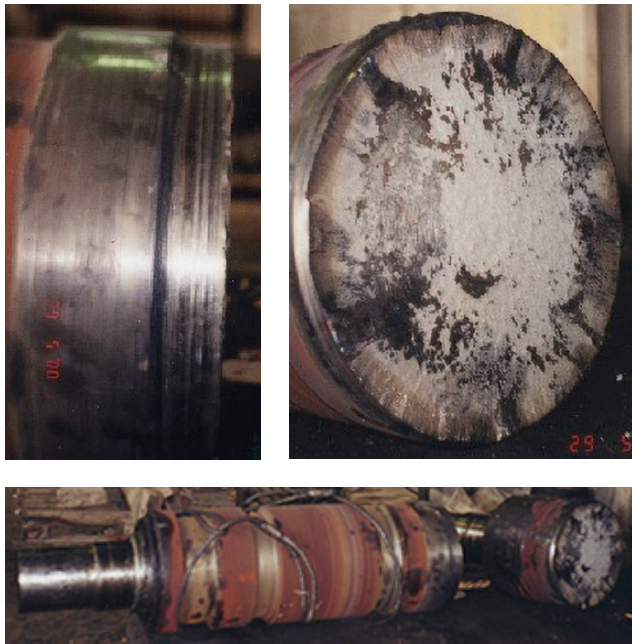
The fourth roll (upper roll) was dressed after 4500 rolling tons and broke after 568 rolling tons after dressing. Figure 7 shows the fourth broken roll and the fracture surface with the position of the stocks at the time of the fracture.

Fig. 7. Fracture surfaces of the 4<sup>th</sup> broken roll and the position of the stocks at time of the fracture

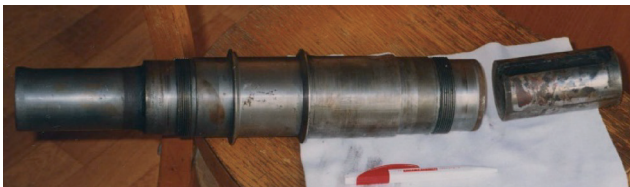
Fig. 14. Stepped drive broken shaft

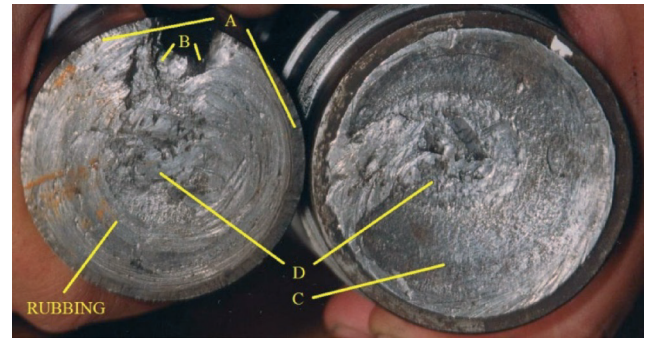
The conclusion from the surface investigation was that the shaft fractured as a result of the rotational-bending fatigue due to high stress concentration. The cracks were initiated

Fig. 15. Fracture surfaces

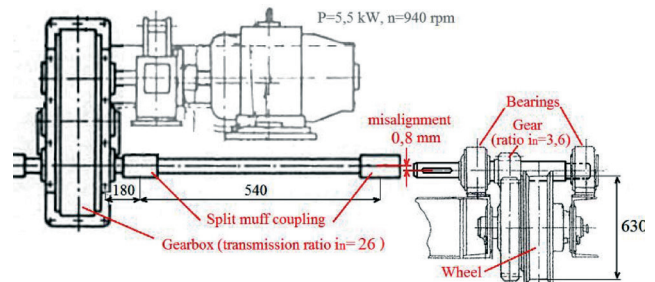
The split muff coupling is a type of rigid coupling and should be used when the alignment of the two shafts can be maintained very accurately. A small misalignment between two shafts can cause high stresses. Post-failure verification revealed parallel misalignment of 0.8 mm between the gearbox shaft axis and the drive shaft axis of the wheel, Figure 16.

Fig. 16. Misalignment between the gearbox shaft axis and drive shaft axis of the wheel

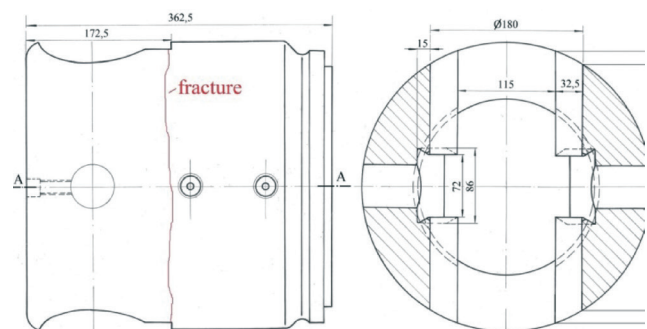
The couplings were made of quenched and tempered steel 30CrNiMo8 according to German standard DIN (Deutsches Institut für Normung), Ref.[2]. The chemical composition of the material was verified by using the quantometer. The hardness readings and microstructure indicated that the coupling had been satisfactorily heat treated by quenching and tempering. The fracture occurred two times in the groove between the paddle and the coupling body, Fig.3.

Fig. 3. Coupling drawing and fracture position

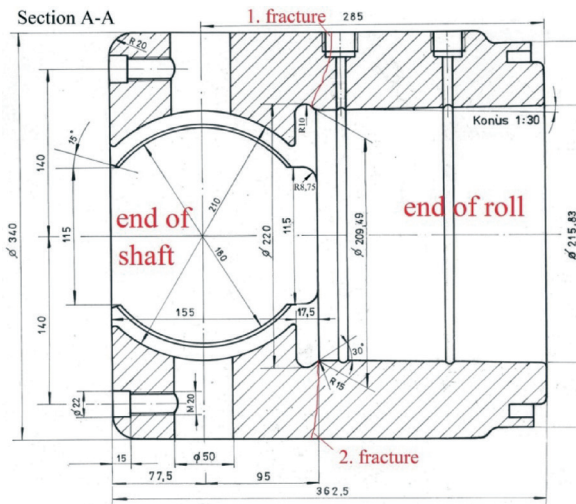
Fig. 4. Coupling drawing – Section A and fracture position

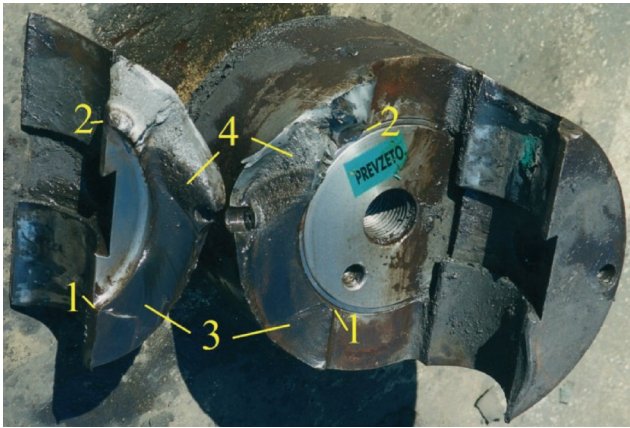
Fig. 5. Fracture of 1<sup>st</sup> coupling

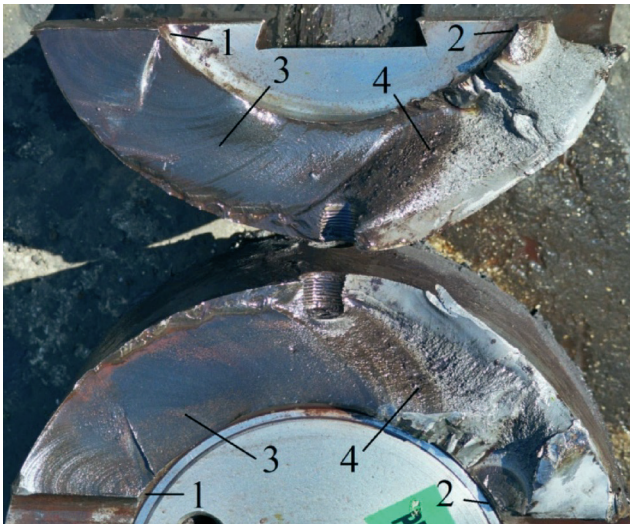
Fig. 6. Fracture surface of 1<sup>st</sup> coupling

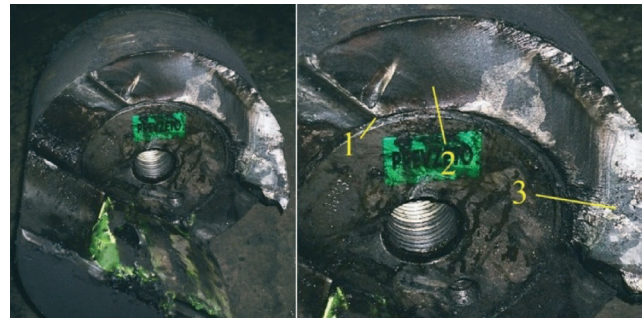
The second broken coupling is shown in Fig. 7.

Fig. 7. Fracture of 2<sup>nd</sup> coupling
