## CONTENT

### Fatigue Failures in Industry and Their Repairs – Case Studies

## Failure analysis of the rolls with grooves

## Failure of two overhead crane shafts

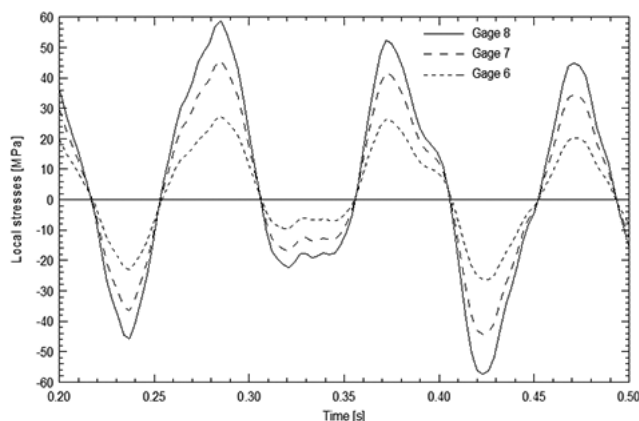
**Fig. 3.** Local stress determination

of the joint. In order to obtain maximum stress, three strain gages were applied (15-17), Fig. 2. As all four supports were not manufactured geometrically identically, on the other side of support 3, strain gage 18 was applied as well as gages 21, 22, 23 on supports 1, 2, 4, respectively. A significant difference of the measured axial forces between the supports was detected. One of the beams was loaded with approx. 50% lower load. However, maximum axial force  $F = 20$  kN (calculated from the nominal stresses) was within the range of design load values. Measurements gave no significant bending moments. The results of nominal stresses ( $\sigma = 10, 15$  MPa) could not be the reason for fatigue cracks, in spite of observed differences from one support to others. Stresses at the crack initiation points were measured to evaluate the quality of design. Three strain gages (15, 16 and 17) were used for extrapolation of maximal stresses. Maximum stresses at the welds toe are extrapolated. Their amplitudes vary depending on the weld design, but the measured values of 70 or even 80 MPa could easily cause the initiation and propagation of fatigue cracks.

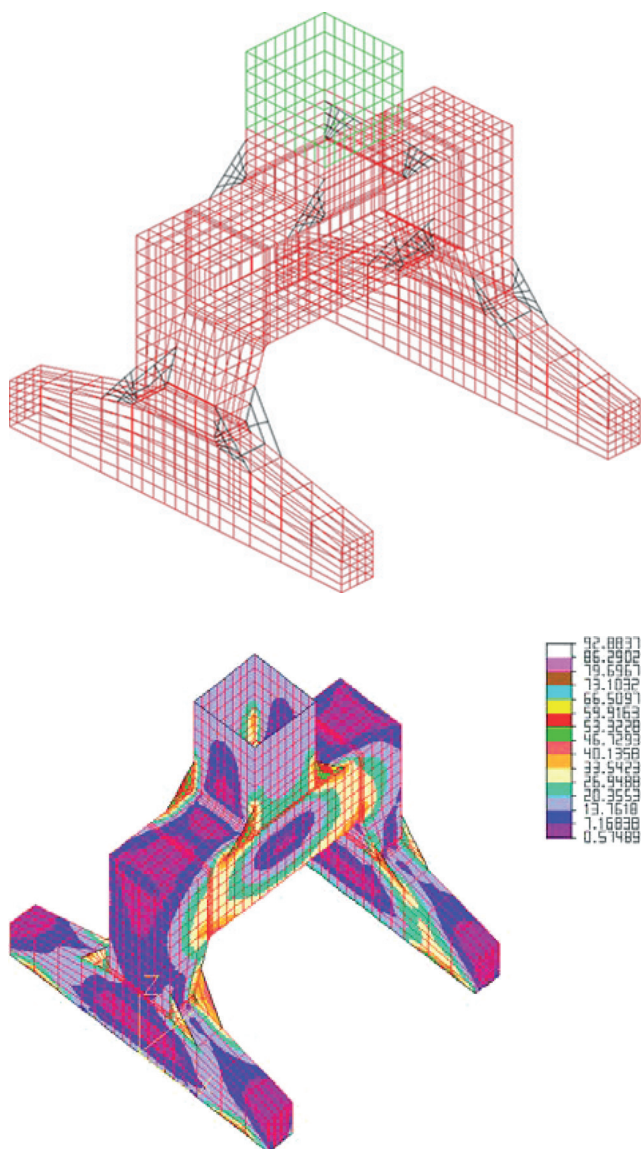
Fig. 6. FEM mesh and some results

- all six degrees of freedom on the nodes at the bottom contour of model were constrained,
- concentrated forces and bending moments are distributed along the nodes on the top of the model, representing the own weight of the upper part of the crane and particular load case. The complete analysis included 17 variants, with various loads, with or without stiffeners, with different orientation of the crane branch and including the construction weight. The mesh and typical results of FEM analysis are shown in Fig. 6.

Strain gauge measurement and FEM analysis showed the source of the crack initiation – high stress concentration in the transition areas from the vertical to horizontal

part of the supports. At critical points those stresses exceeded the fatigue strength of the material and caused the crack initiation and growth. Variable loads cannot be avoided, so the only solution was to redesign the critical areas in order to redistribute local stresses. FEM analysis also showed the best way for redistribution of high stresses: application of triangle stiffeners that fit the existing construction (Fig. 7). Those stiffeners were welded by using the MAG process. Heat treatment was used to minimize residual stresses, and fatigue limit of welds increased by grinding the weld toes and roots. After the repair was completed, stresses at critical points were measured once again and compared to the values predicted by FEM. According to the data obtained from FEM and strain gauges measurements, it is clear that stresses at critical points were significantly lowered, especially in critical areas. All the stresses were under the fatigue limit, so the main source of crack growth was removed.

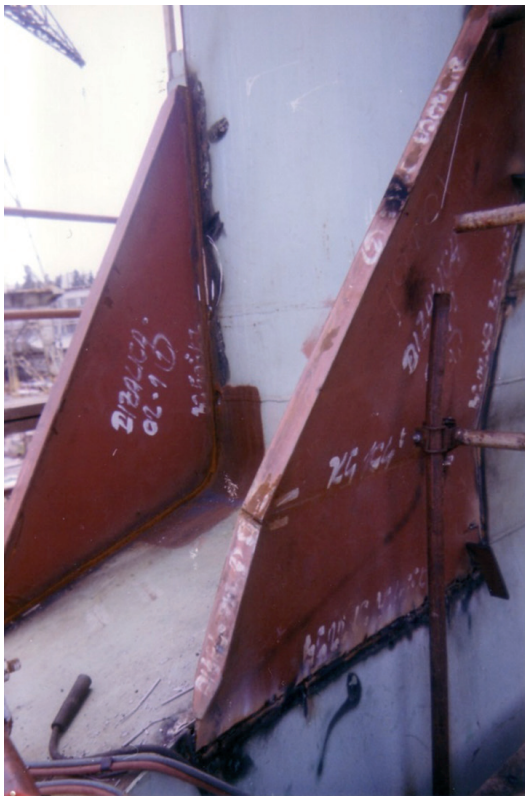
Fig. 7. Positions of attached strain gauges

- the highest measure of stress amplitude was about 150 MPa, but in practice stresses can be higher, due to several reasons: – strain gauges were not attached at the places of highest stress concentration (access is not possible because of cracks)
- stress concentration factor  $k_t$  is about 2, what is not theoretical maximum
- crack opening displacements reached 1.5 mm, what according to the Fracture Mechanics COD – concept indicates the stress of about 200-300 MPa
- measured values of acceleration were up to  $0.2 \text{ m/s}^2$ , what is acceptable, but during the test the crane was driven very carefully – in every day's use, and under the influence of wind, these values can be higher.

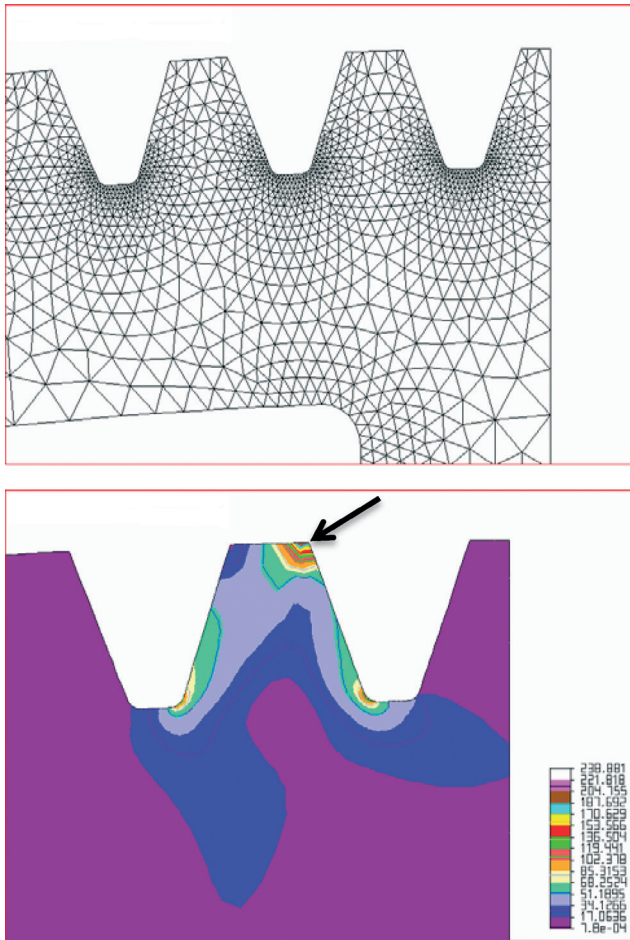
Fig. 12. Stress distribution and stress concentration

During each revolution of the cement mill and large gear, every tooth was loaded twice (two small gears) by tooth force alternating from zero to the maximum value. Numerical method (FEM) was used to determine the stress distribution at the gear rim. Calculated maximum stress amplitudes were found at the tooth fillet, approximately 50–115 MPa, depending on their positions on the surface. Stress intensity decreased very fast in the depth of the gear rim.

These stress values could not be the only reason for cracks initiation and propagation. In spite of a great number of cracks and one complete failure of the gear ring, repair welding was performed. All necessary steps for the best quality insurance (best welders, best welding rods,

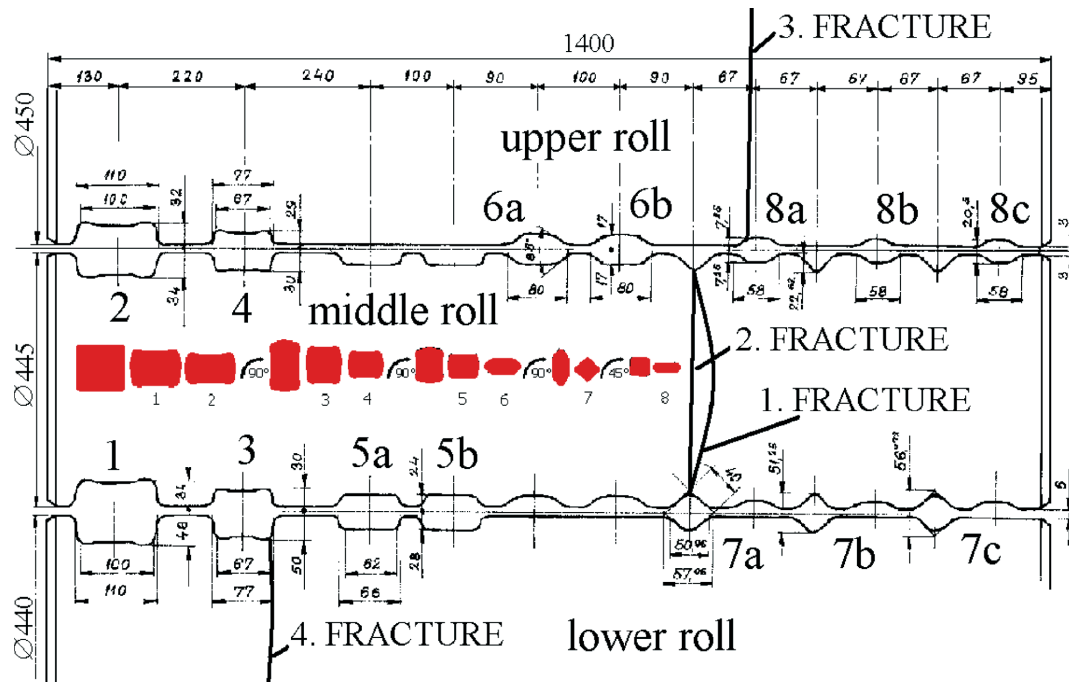
Fig. 2. Roll design and groove distributions

The pass schedule and corresponding dimensions are given in Table 1. Figure 2 shows the roll design and groove distributions with positions of the failures.

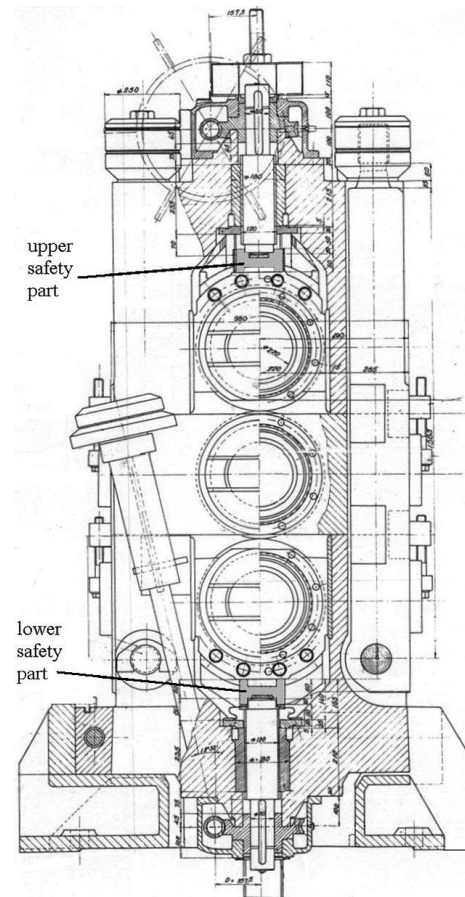
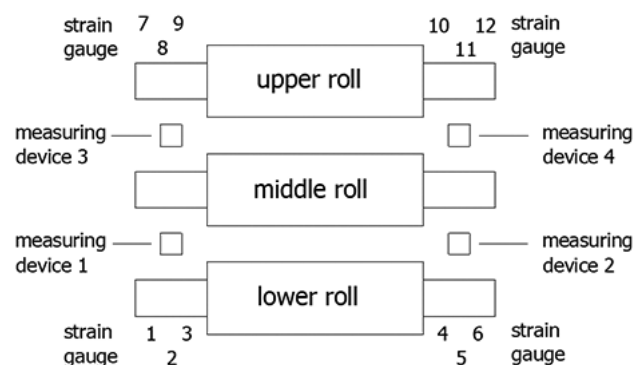
Fig. 8. Measurement system and measuring devices

In accordance with results from analytical methods for determining the rolling force, four measuring devices with three strain gauges on each, were designed for the experimental determination of rolling force (Fig. 8). The

measuring devices were mounted on both sides of the stand, instead of safety parts against the breakage of rolls (Fig. 8).

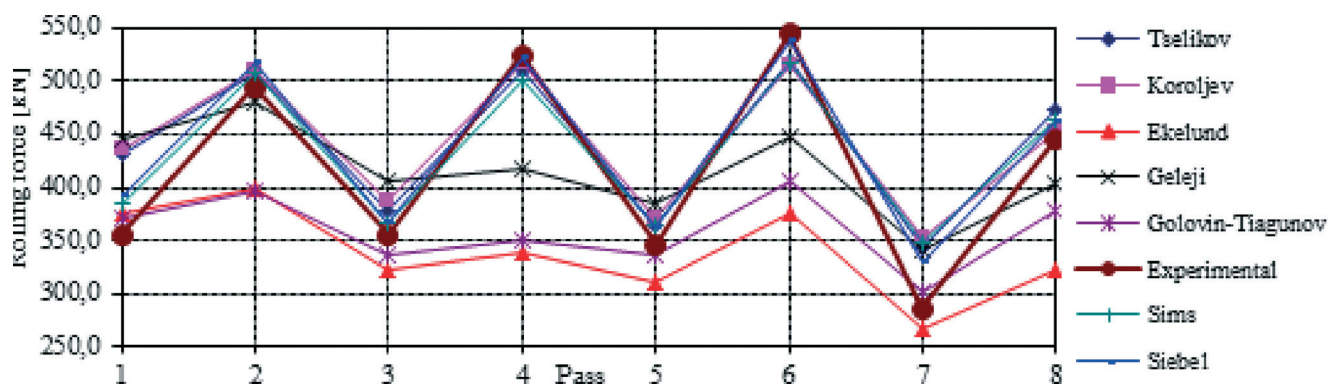
Fig. 9. Analytical and experimental results

Figure 9 shows the experimental and analytical results.

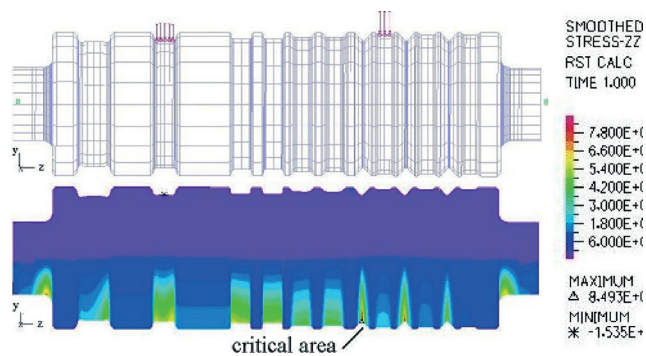
Fig. 10. Numerical analysis

The obtained experimental results of the rolling forces are used for numerical analysis of the local stresses by finite element method. The FEM revealed that the most critical area of the roll is 7.a pass. The linear elastic model with 3D solid elements with eight DOF per nodes was used. The complete numerical analysis included 30 cases according to the rolling schedule. Fig. 10 shows the FEM model of the middle roll with the positions of

the stocks in 4. and 8.a passes and maximum stress amplitudes of approximately 85 MPa in the 7.a pass.

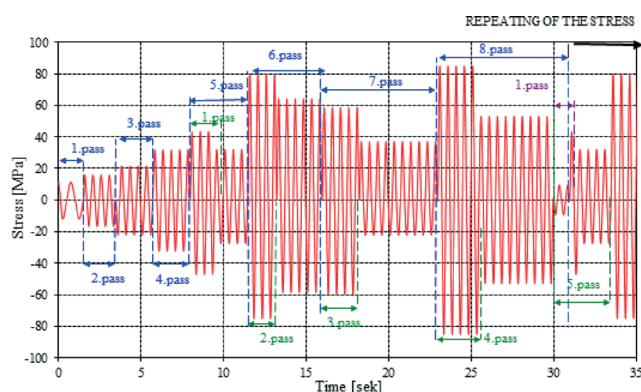
Fig. 11. Stress time history at the critical area for one billet

Stress time history of the individual local stress and stress spectrum are obtained from numerical analysis and pass schedule. Figure 11 shows stress time history of the local stress in the 7.a pass for only one billet.

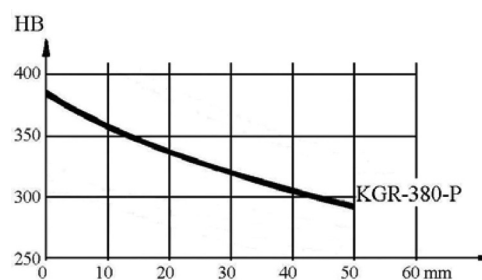
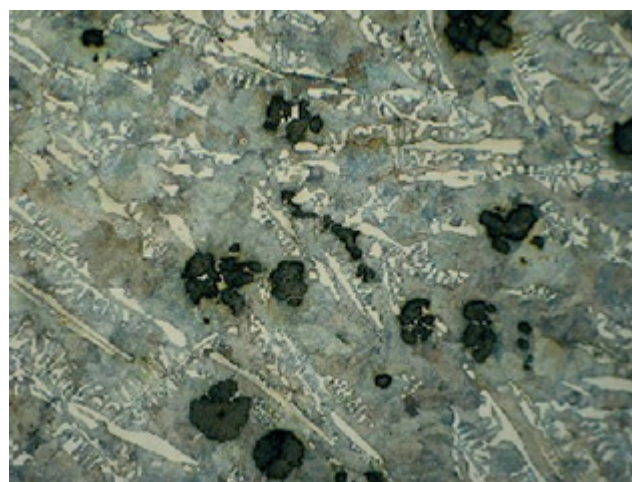
Fig. 12. Hardness drop and metallographic structure (500x)

The material used for rolls is spheroidal graphite iron with the pearlitic base. Chemical composition of the roll material is 3.4÷3.6 % C, 1.8÷2.2 % Si, 0.5÷1 % Mn, < 0.05% P, < 0.05% S, < 0.5% Cr, 1.5÷3% Ni and <0.2% Mo. Hardness on the roll surface is 380 HB. Fig. 12 shows hardness drop of KGR 380 rolls and metallographic structure of the roll material.

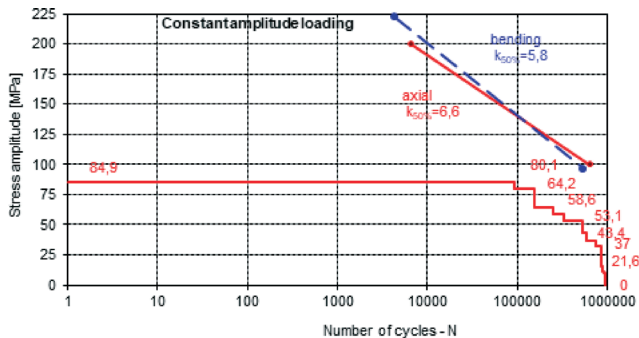
**Fig. 13.** Fatigue strength of the roll material and stress spectrum in the critical area for 4000 rolling tons

This diagram reveals that failures should be avoided in normal service without overloads.

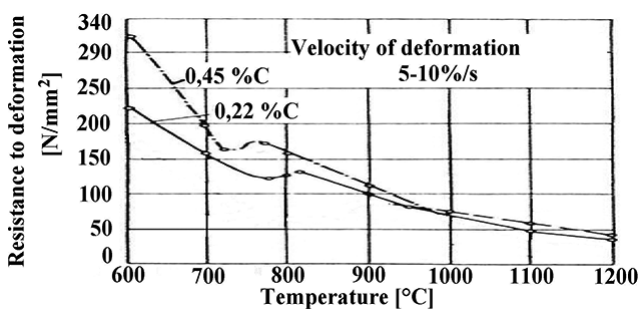
**Fig. 14.** Resistance to deformation of carbon steels related to temperature

The temperature of the rolling material has a great influence on the rolling forces. When the rolling process is carried out at a decreased temperature, the rolling forces are higher and bending stresses can be two or three times higher than usually (Fig. 14).

During the rolling process some of the rolling stocks stayed on the rollers outside of the furnace due to technological stops. The temperatures of these stocks decreased due to cooling by ambient air. No sensors of the temperature of a rolling stock between the furnace and 3-high-roughing mill stand were anticipated and there was no control of decreasing rolling temperature between the furnace and 3-high-roughing mill stand. Because of this fact the rolls were occasionally subjected to higher rolling forces and bending overloads as the result of technological stops.

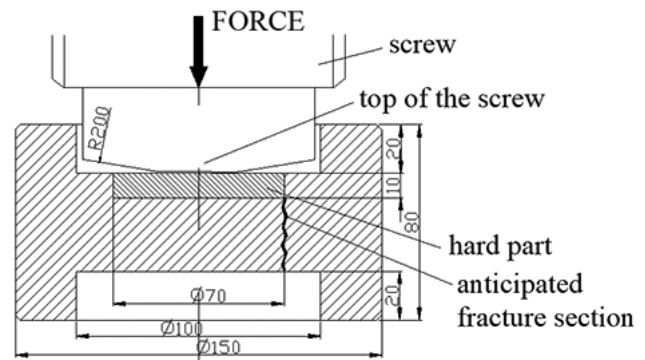
**Fig. 15.** Safety part

The rolls are protected from bending overload with the safety parts (Fig. 8). In case of the bending overload, one (or both) safety part has to fail before the failure of the roll. The material used for safety parts was flake graphite iron GG20 according to DIN. Figure 15 shows the safety parts design.

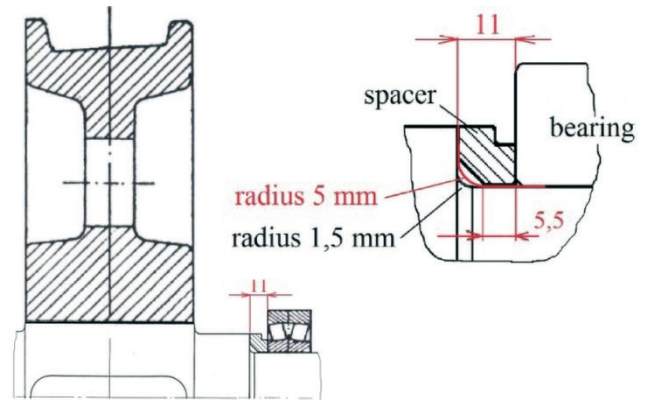
Fig. 7. Design of the spacer

The distance between the large diameter of the shaft (wheel) and the bearing was 11 mm, Figure 7. The spacer was positioned between the wheel and bearing. Increasing the size of the fillet radius was limited by the design of the spacer.

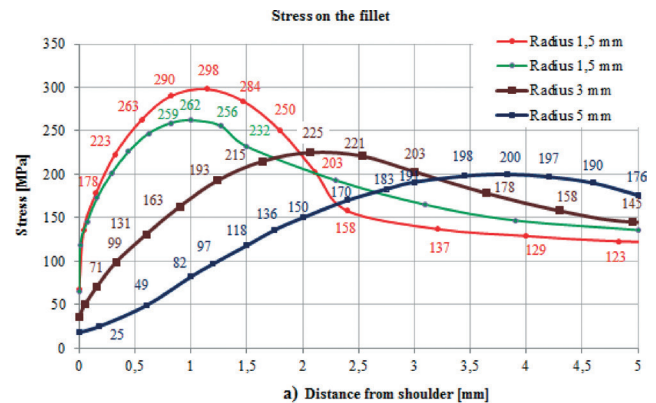
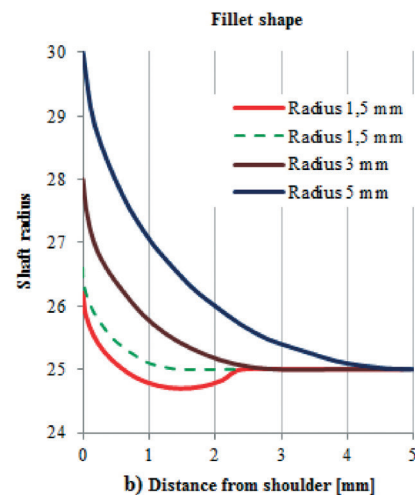
Fig. 8. Stress distribution

The curves in Figure 8 show the increasing size of the fillet radius from 1.5 mm to 5 mm, reducing maximum local stress by about 1.5 times (from 298 to 200 MPa).

Therefore, numerical experiments were carried out for four different sizes of the fillet radius in order to reduce local stresses below the endurance limit, Figures 8 and 10.

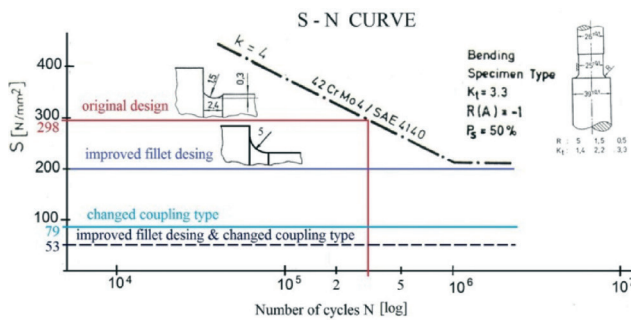
Fig. 10. Influence of corrective actions on fatigue life

Figure 10 shows the influence of considered corrective actions on fatigue life.

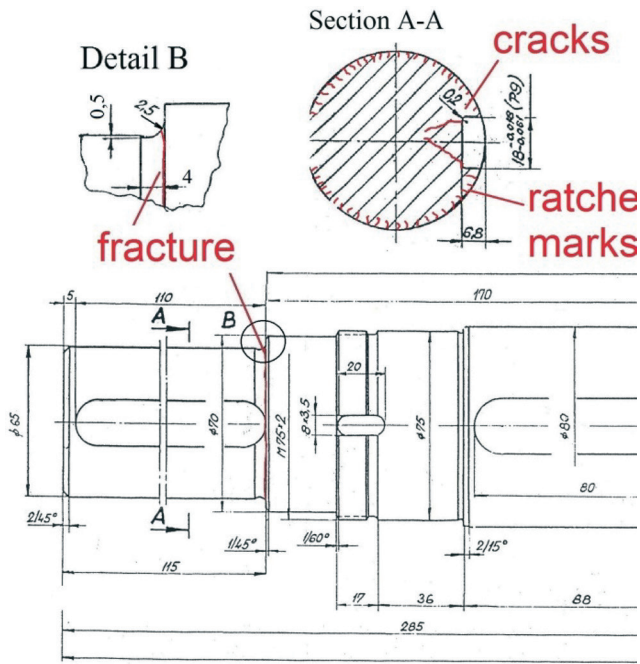
Fig. 13. Stepped drive shaft [8]

In this case there were two stress raisers in the same area: a sharp corner in the keyway and a change in the shaft diameter. Additionally, the end of the keyway was due to change in the shaft diameter, fracture section in Figure 13, causing high concentration of stresses.

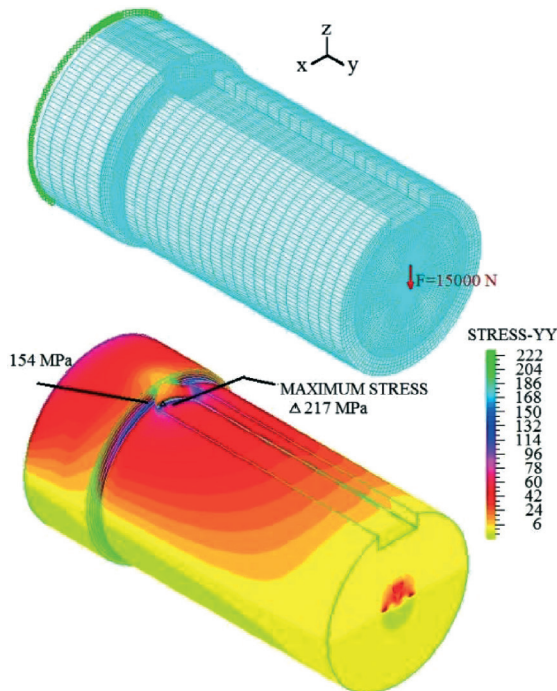
Fig. 18. Numerical analysis

The linear elastic model with 3D solid elements with eight DOF per nodes was used, Figure 18. Each node had 3 degrees of freedom, translation in X, Y and Z direction. The model is fixed in the back side face and loaded with concentrated forces in the node on the front side.

The FEM analysis of local stresses revealed that the maximum stress 217 MPa was in the sharp corner of the keyway and the stress on the fillet due to change in the shaft diameter near the keyway was 154 MPa, Figure 18. Stress concentration factors in critical areas had a good agreement with literature [4] and [5].

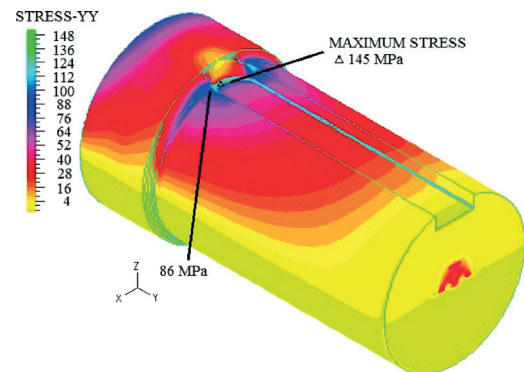
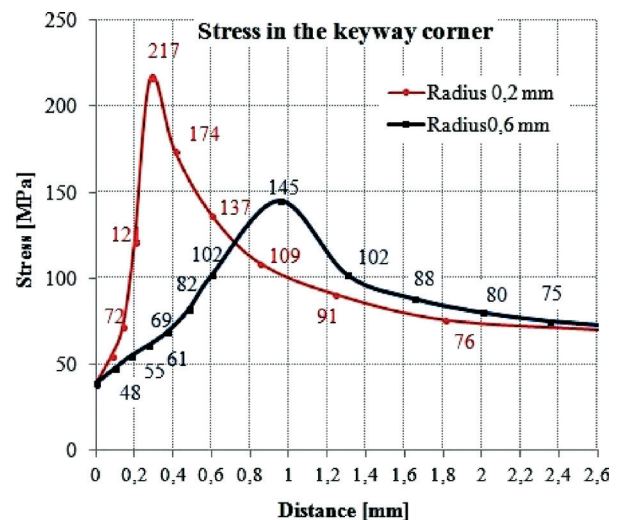
Fig. 20. Numerical analysis

The FEM analysis of local stresses after the redesign revealed decreasing the maximum bending stress in the sharp corner of the keyway from 217 MPa to 145 MPa as well as decreasing stresses of the fillet radius due to change in the shaft diameter from 154 MPa to 86 MPa, Figure 20.

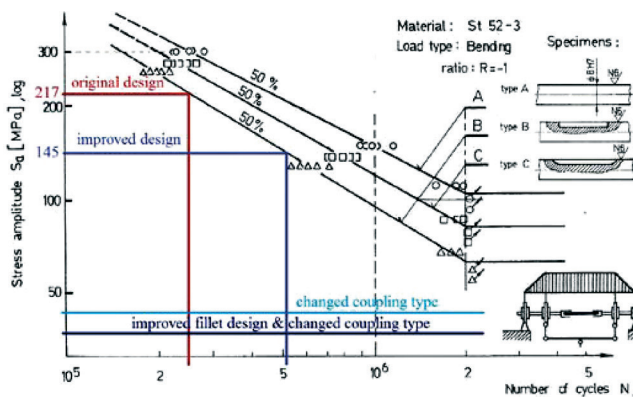
Fig. 21. Influence of corrective actions on the fatigue life

Figure 21 shows the influence of considered corrective actions on the fatigue life. The fatigue strength curve of the material is used from literature [11].

The actual service life was estimated from the working time of the crane, the number of liftings and the wheel diameter. The crane was in service for about 800 working days during a three year period. The average number of transports per day was 20 with the travel of the trolley 12 m per each transport. For the wheel diameter of 630 mm and the corresponding shaft, the actual service life was  $3.5 \cdot 10^5$  cycles. The estimated service life from the numerical model was about  $3 \cdot 10^5$  cycles, Figure 10.

A gear coupling was considered to substitute the split muff coupling since post-failure verification revealed parallel misalignment of 0,8 mm between two shaft axes. The application of gear couplings can eliminate force on the shaft due to misalignment and can also reduce local stresses on the critical area.

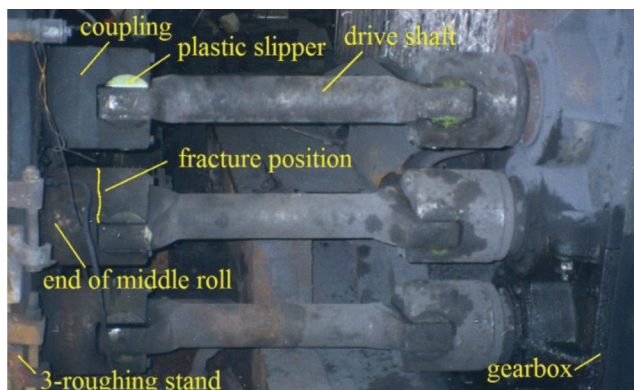
Fig. 2. Shafts and couplings between the 3-high-roughing stand and the gearbox

Slipper couplings and drive shafts are used to transmit torque between gearbox and 3-high-roughing mill stands. A failure of both couplings occurred on the middle roll between the first stand and the gearbox, roll side, Fig.2.

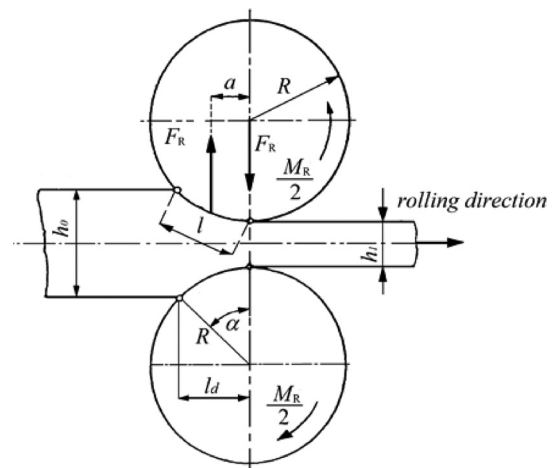
The rolling stock passes between two rolls and torque required for deformation is torque of two rolls, Fig. 8. The equation for rolling deformation torque, Ref. [3], is given by

Fig. 8. Rolling force and rolling deformation torque

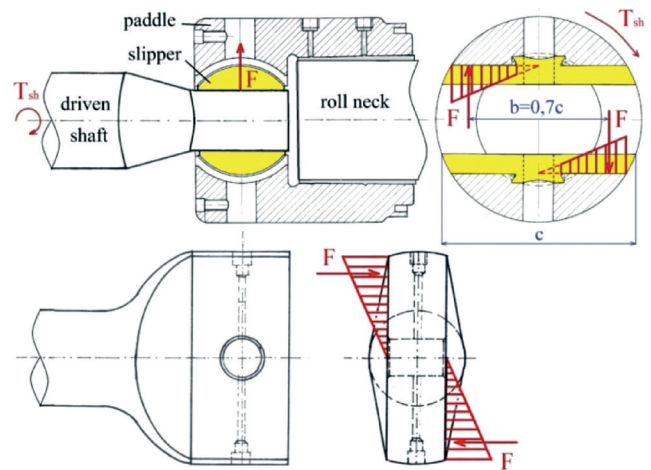
The plastic slippers are installed between the coupling paddles and the driven shaft, Fig.9.

where  $F$  is resultant force of distributed load and  $b$  is distance between resultant forces, Fig.9.

Fig. 9. Coupling load

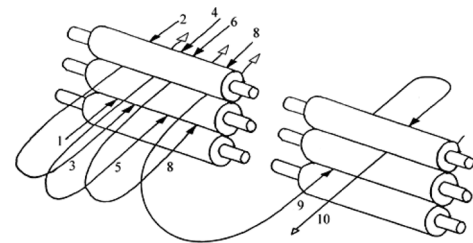
Fig. 10. Roughing mill schema

Rolling in the roughing mill consists of 10 passes in two stands, 8 in the first stand and 2 in the second stand, Fig.10. In each pass a different rolling force acts, Fig.11, and the corresponding rolling deformation torque.

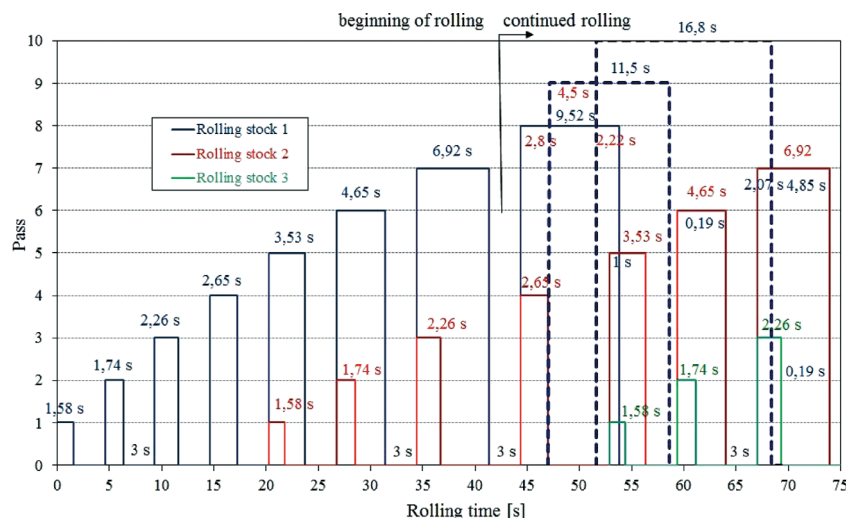
Fig. 12. Roughing mill rolling process

The middle drive shaft between the gearbox and the 1<sup>st</sup> stand transmits half of the total rolling torque following a rolling sequence of 8 passes in the first stand and 2 passes in the second stand, Fig.12.

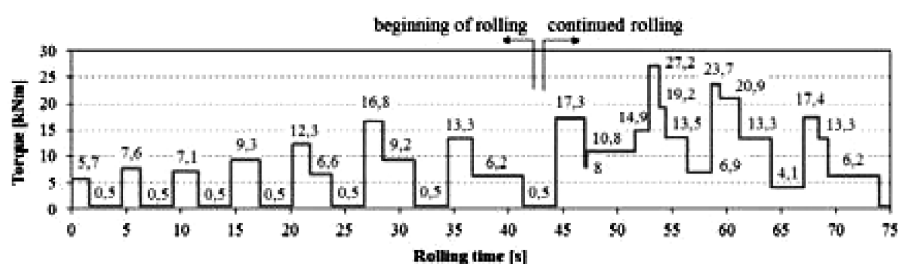
The diagram in Fig.13 shows that torque change follows the rolling schedule. In pass 1, the torque value was 5.7 kNm with a duration of 1.58 seconds. In pass 2 the torque value was 7.6 kNm with a duration 1.74 seconds.

**Fig. 13.** Drive shaft torque change according to time

In pass 3 the torque value was 7.1 kNm in 2.26 seconds and 9.3 kNm in 2.65 seconds in pass 4. For rolling two stocks in pass 1 and 5 the torque value was 12.3 kNm with a duration of 1.58 seconds, which is a sum of the torque values in passes 1 and 5. Rolling in pass 1 finished after 1.58 seconds, and the torque value was 6.6 kNm with a duration of 295 seconds due to rolling in pass 5.

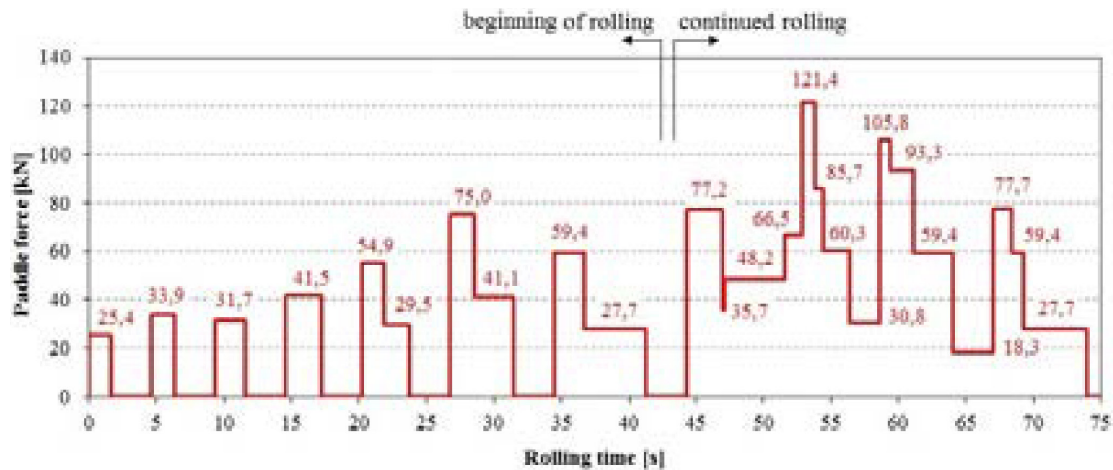
Fig. 14. Paddle force change according to time

The diagram in Fig.14 shows that the maximum paddle force was 121.4kN during the rolling of three stocks together in passes 1, 5 and 8, 9 and 10 with a duration of 1 second.

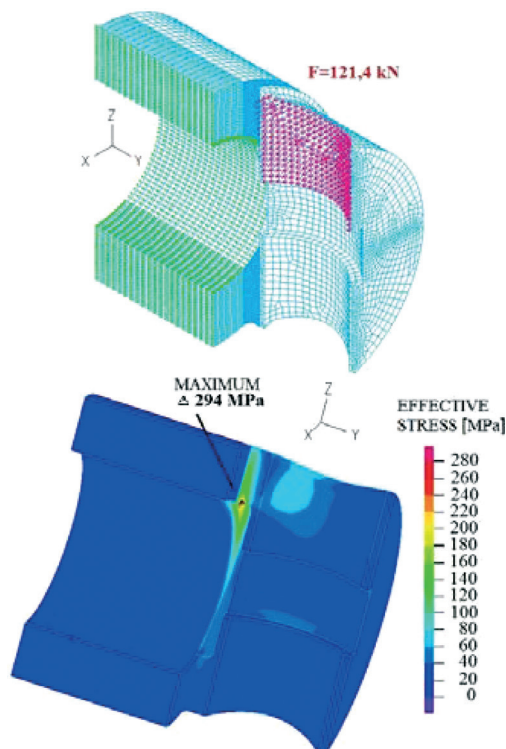
FEM analysis of the slipper coupling revealed that a force of 121.4 kN caused the maximum stress of 294

Fig. 15. Numerical analysis of the slipper coupling

MPa on the fillet between the paddle and the coupling body, Fig.15, in the same place where both fractures originated. FEM analysis of the drive shaft revealed that the maximum stress of 65 MPa appeared due to change in the shaft diameter, Fig.16, and that the drive shaft was not the critical point.

The analysis showed that both fractures were caused by the deficient design of the fillet between the paddle and the coupling body with high stress concentration. In order to extend the actual service life, three design modifications were considered:

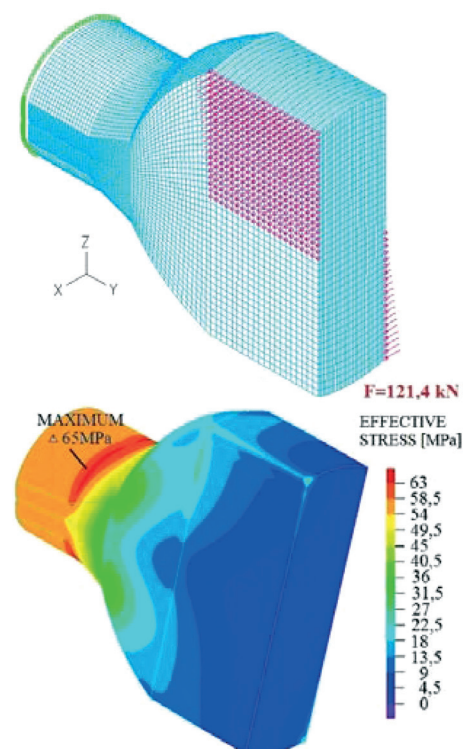
Fig. 16. Numerical analysis of the drive shaft

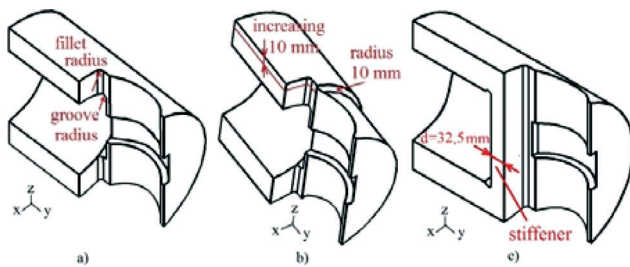
Fig. 17. Considered actions

- Decreasing the stress concentration in the corner between the paddles and the coupling body by change of the fillet radius and the groove radius, Fig.17a;
- Increasing the external diameter of the coupling in the critical place, Fig. 17b and
- Redesign of the coupling with stiffener between the paddle and the coupling body, Fig. 17c.

In the first and the second solution the redesign was limited only to reshape the coupling and did not request any change of the shaft. The third solution involved also redesigning the shaft – reducing the shaft length by 100 mm.

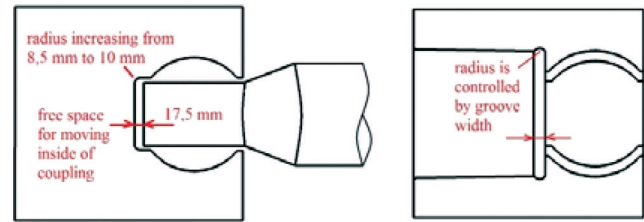
The high stress concentration is caused by two stress raisers, the fillet and the groove in the corner between the paddle and the coupling body. The change of the fillet and groove radius was analyzed in order to reduce stress concentration. The radius of the fillet was limited by the free space necessary to move the shaft the coupling and can be increased from 8.5 mm to 10 mm, Fig.18. The radius of the groove was controlled by the groove width and the groove width could not be increased, Fig.18.

FEM analysis of local stresses revealed that a redesign by changing the radius of the fillet will slightly decrease local stresses.

Fig. 18. The space between the shaft and the coupling

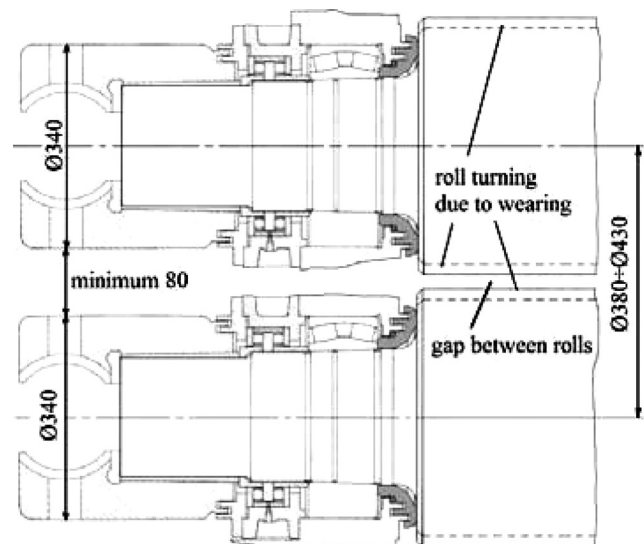
The rolls during exploitation reduce the working diameter by turning due to roll wearing. The gap between the rolls should be adjusted in the requested dimension by reducing the distance between the roll axes. Because of that, the minimum of the free space between the external diameters of two couplings was 80 mm, Fig. 19, which allowed increasing the external diameter of the coupling from 340 to 360 mm. Additional increasing the external diameter may disturb the assembly and maintenance work.

Fig. 19. Space between the external diameters of two couplings

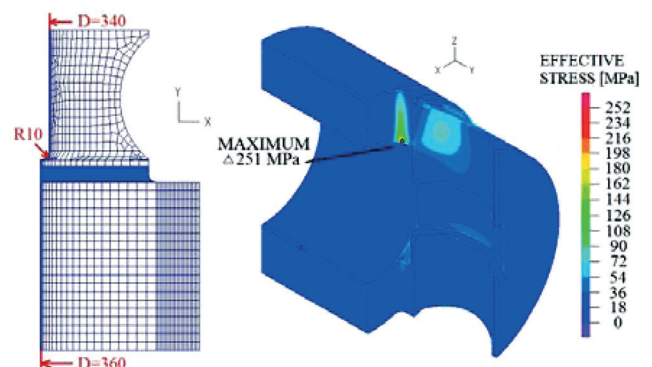
FEM analysis of local stresses revealed that increasing the external diameter from 340 mm to 360 mm reduced the maximum local stress from 294 MPa to 251 MPa, Fig. 20.

Fig. 20. FEM analysis with the increased external diameter

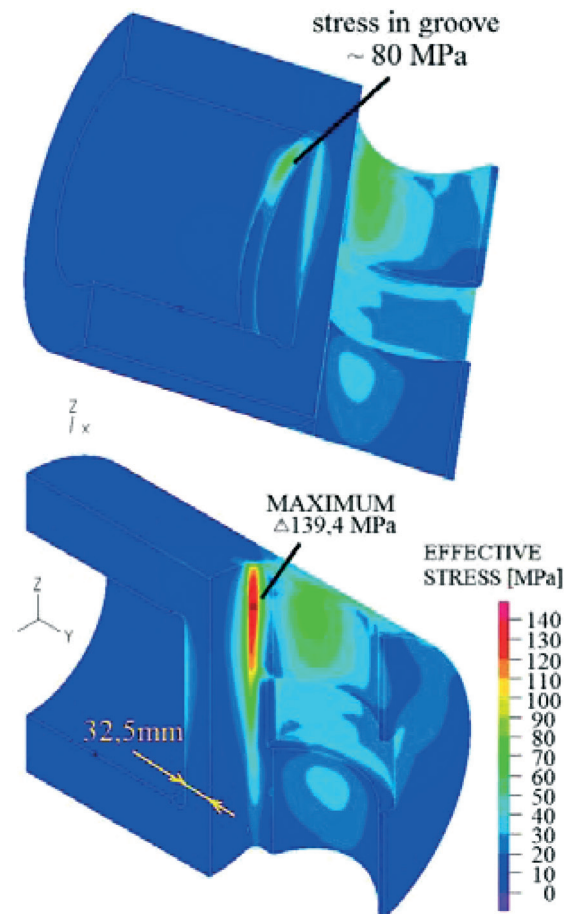
In the original design there was an interference of two stress raisers, the fillet and the groove. The redesign of the coupling with stiffener between the paddle and the coupling body was considered in order to split influences of stress raisers on local stresses. A numerical analysis of local stresses was carried out for the new design with a stiffener thickness of 12.5 mm and 32.5 mm, Fig. 21. With the new design, the distance between the fillet centre and the groove centre with a stiffener thickness of 12.5 mm was 30 mm and with 32.5 mm it was 50 mm.

Fig. 21. FEM analysis of the new coupling design with a stiffener thickness of 32.5 mm

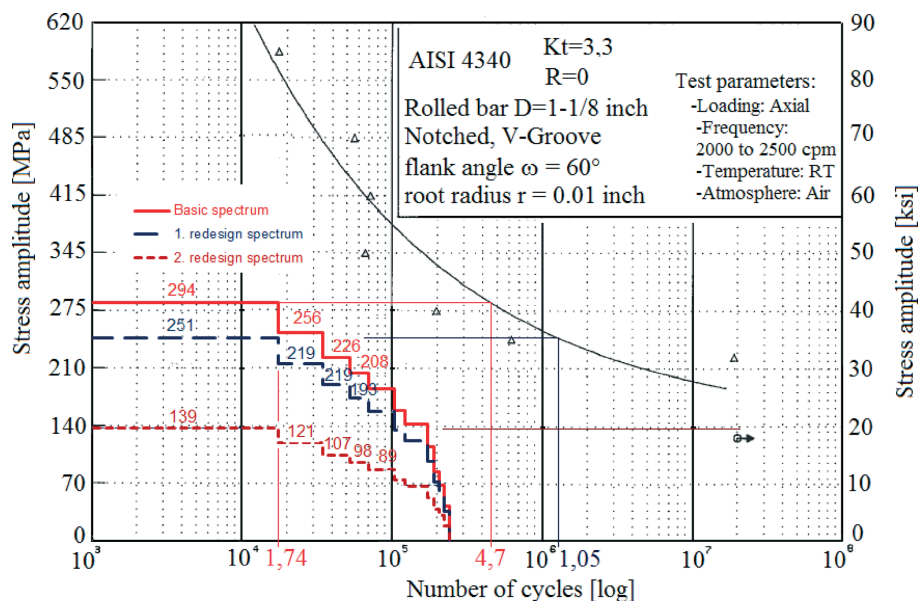
Based on this data, the actual service life of the coupling was estimated for 27 working sequences, (469530 divided by 17390 is 27), or 405 working days (time period about 3 years), Fig. 22. The fatigue strength curve of the

Fig. 22. Stress spectra for critical area

The redesign by increasing the external diameter of the coupling in the critical place reduced the maximum local stress by about 15% (from 294 MPa to 251 MPa) and increased fatigue life by about 100% according to the actual estimated fatigue life, Figure 22.
